Report of Flux Leakage Inspection

Eclipse: STEAM BOILER

Serial: 47153

Location: USA SCHOOL
3355 First Steet
SOMEWHERE, US 00002

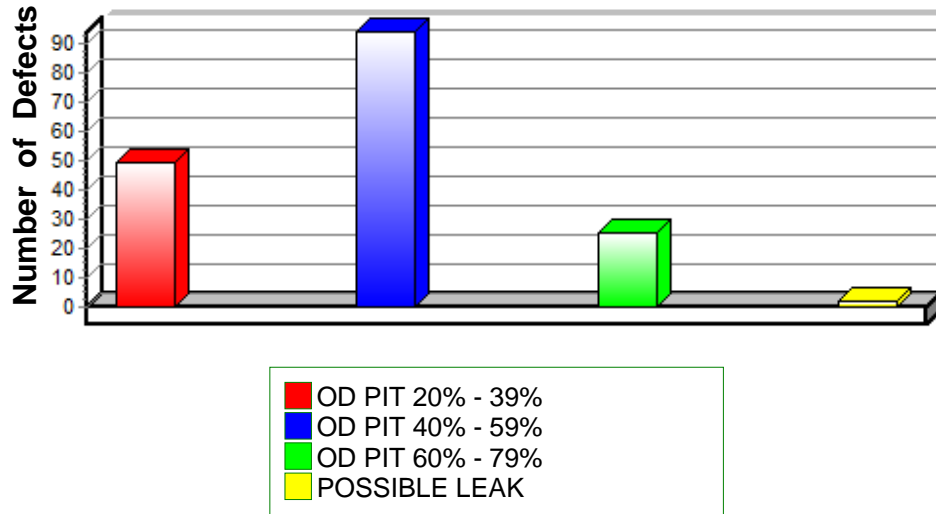
Boiler Defects

Boiler: 170 Tubes		
Significant/Measurable Indications	Number of Tubes Tested	Percent of Bundle
OD PIT 20% - 39%	49	28.82
OD PIT 40% - 59%*	94	55.29
OD PIT 60% - 79%*	25	14.71
POSSIBLE LEAK*	2	1.18
Totals	170	100.00

We recommend tubes indicating OD Pits of 40% or more be isolated from the system at this time. Tubes indicating OD Pits of less than 40% require no corrective action but should be monitored for defect growth.

We recommend tubes marked for leaks be isolated from the system at this time.

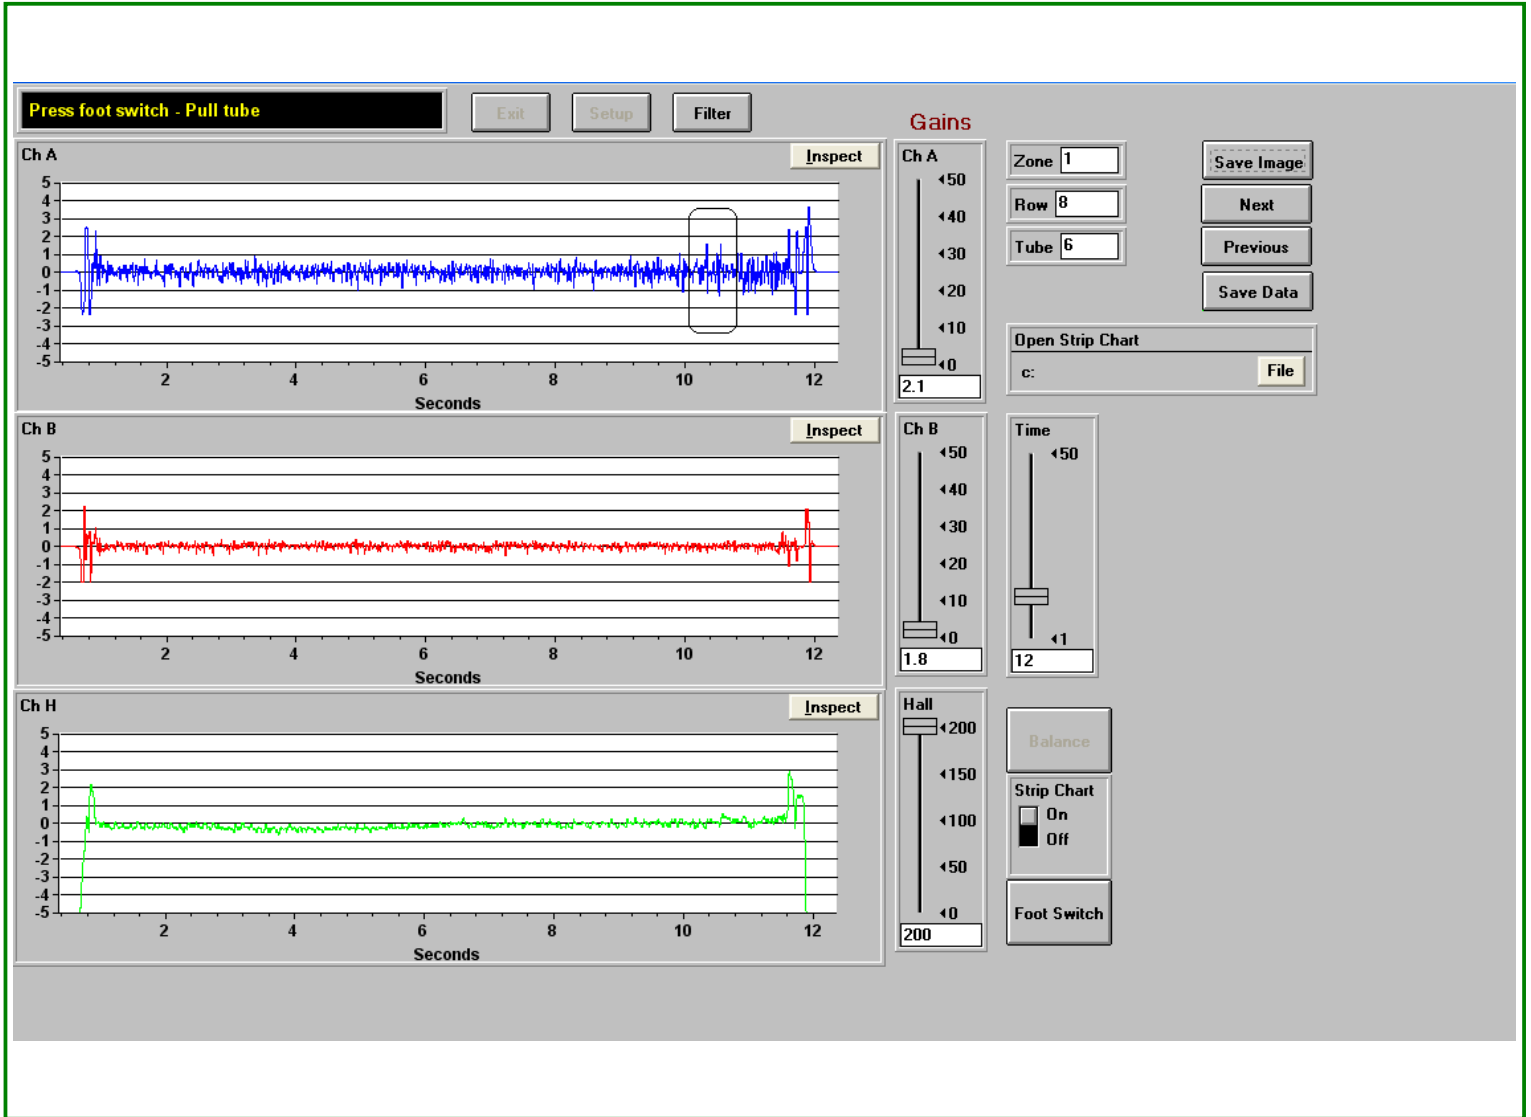
OD PIT 20% - 39% (Row 8 Tube 6)

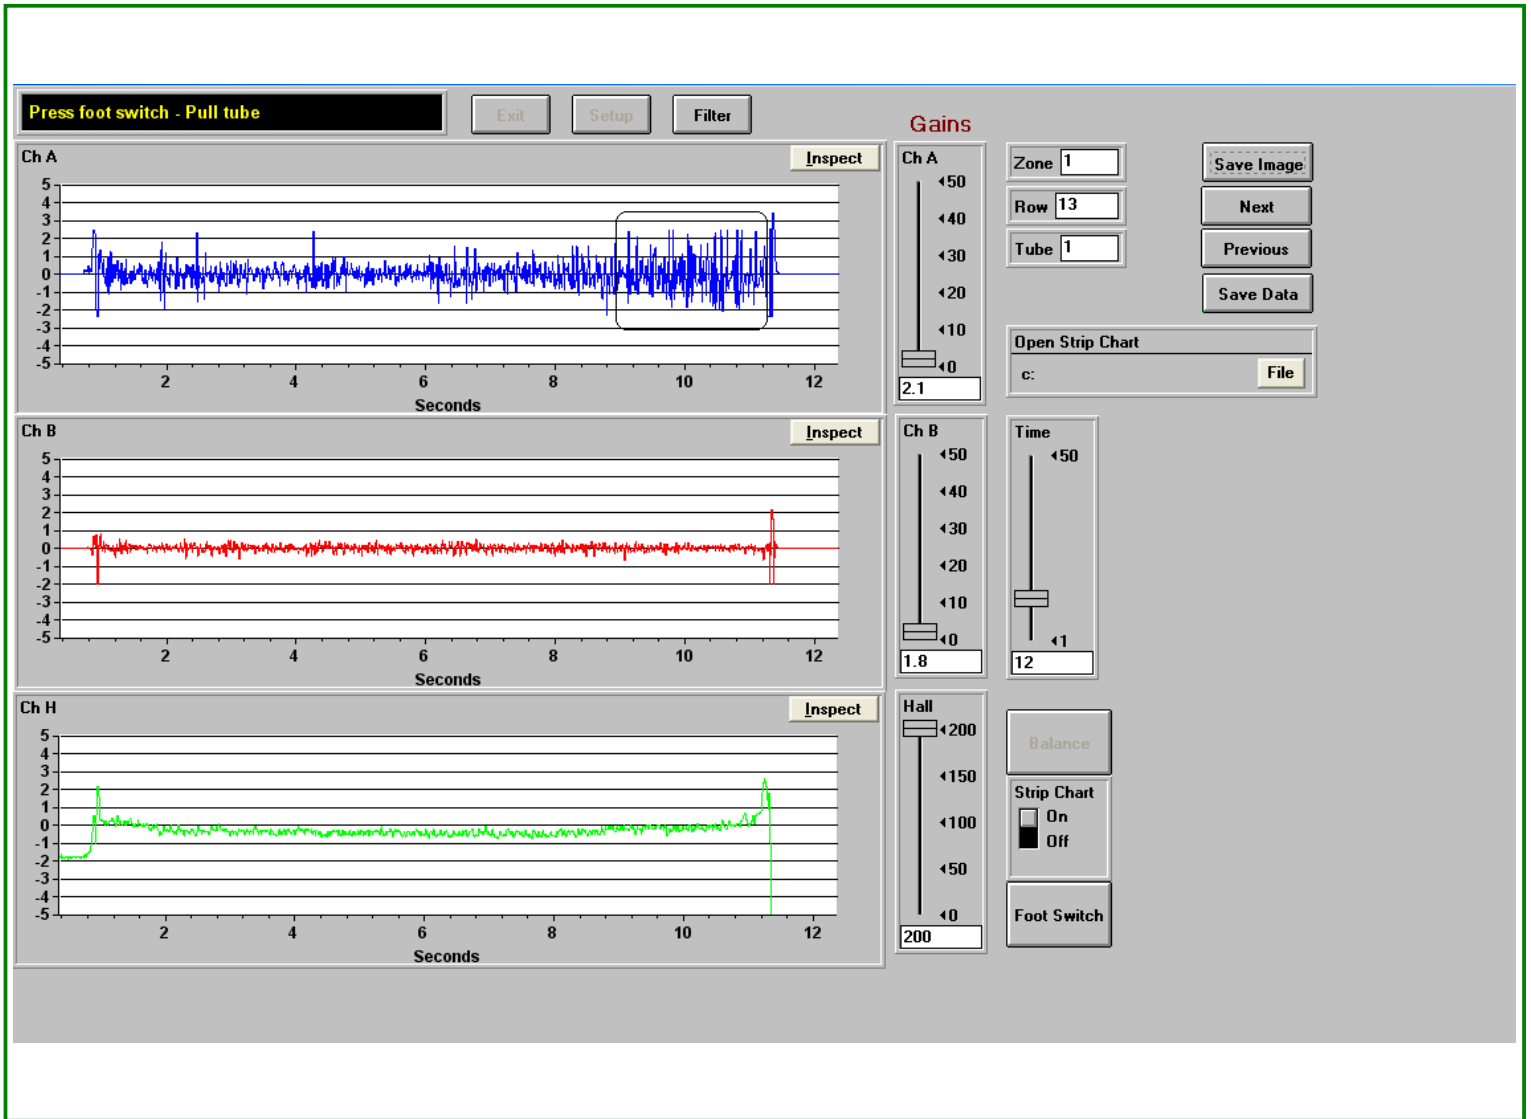
OD PIT 60% - 79% (Row 13 Tube 1)

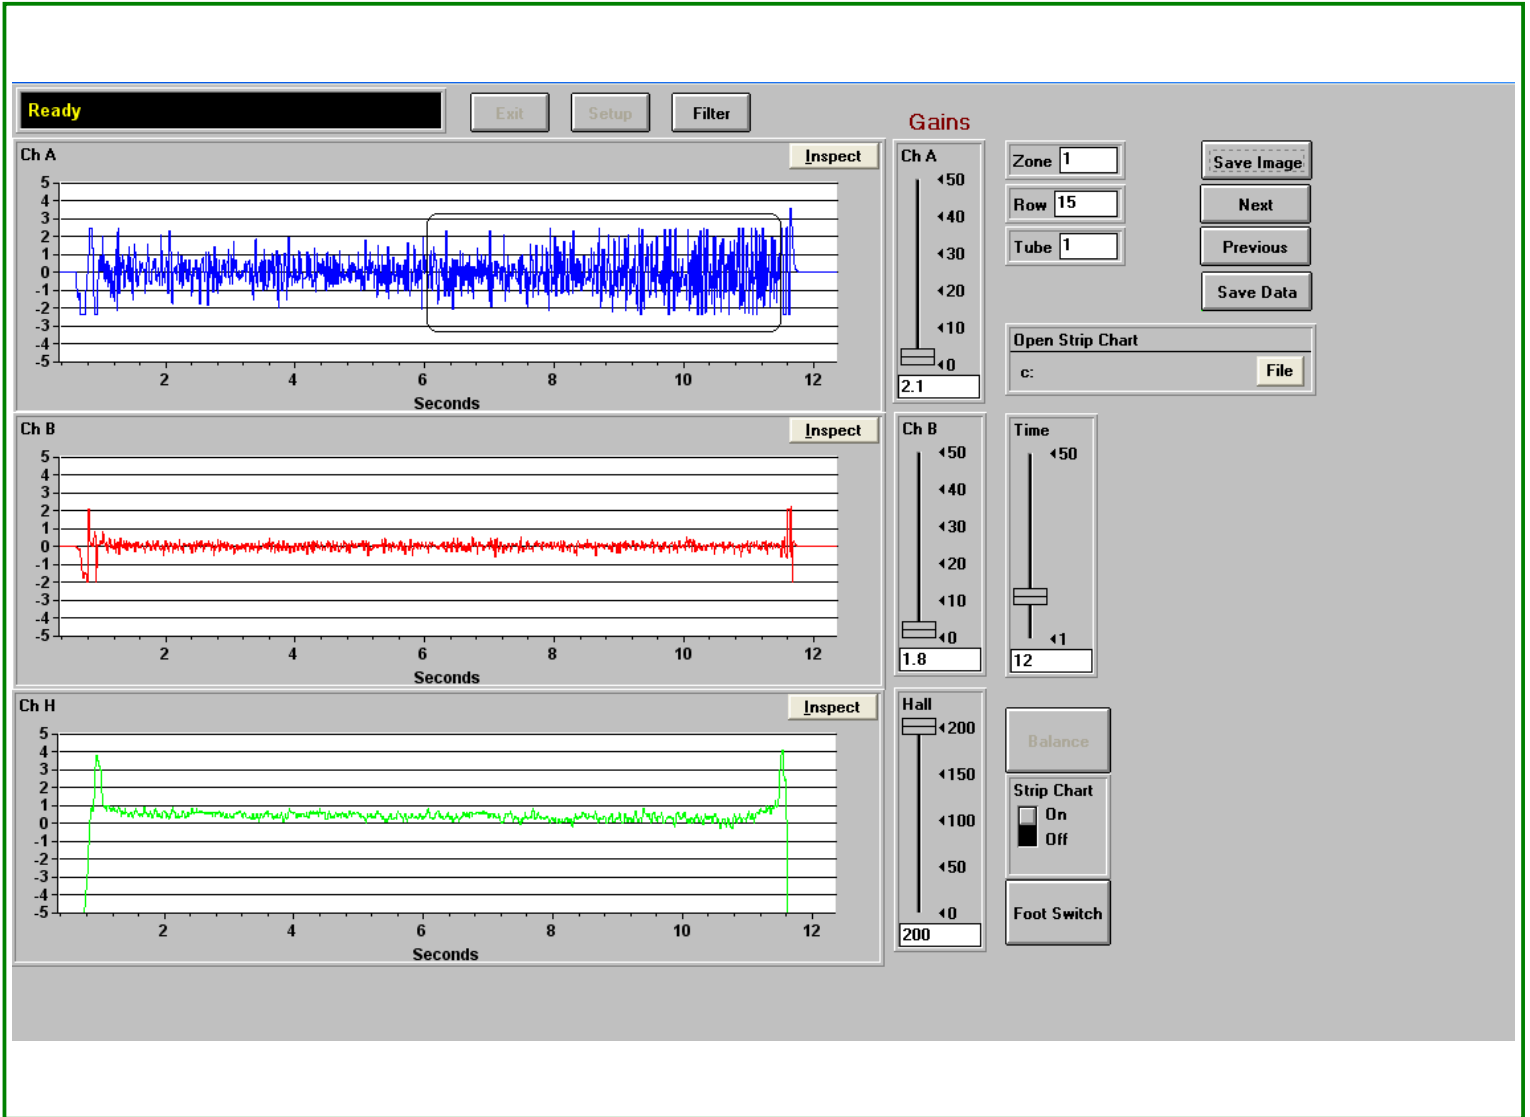
OD PIT 60% - 79% (Row 15 Tube 1)

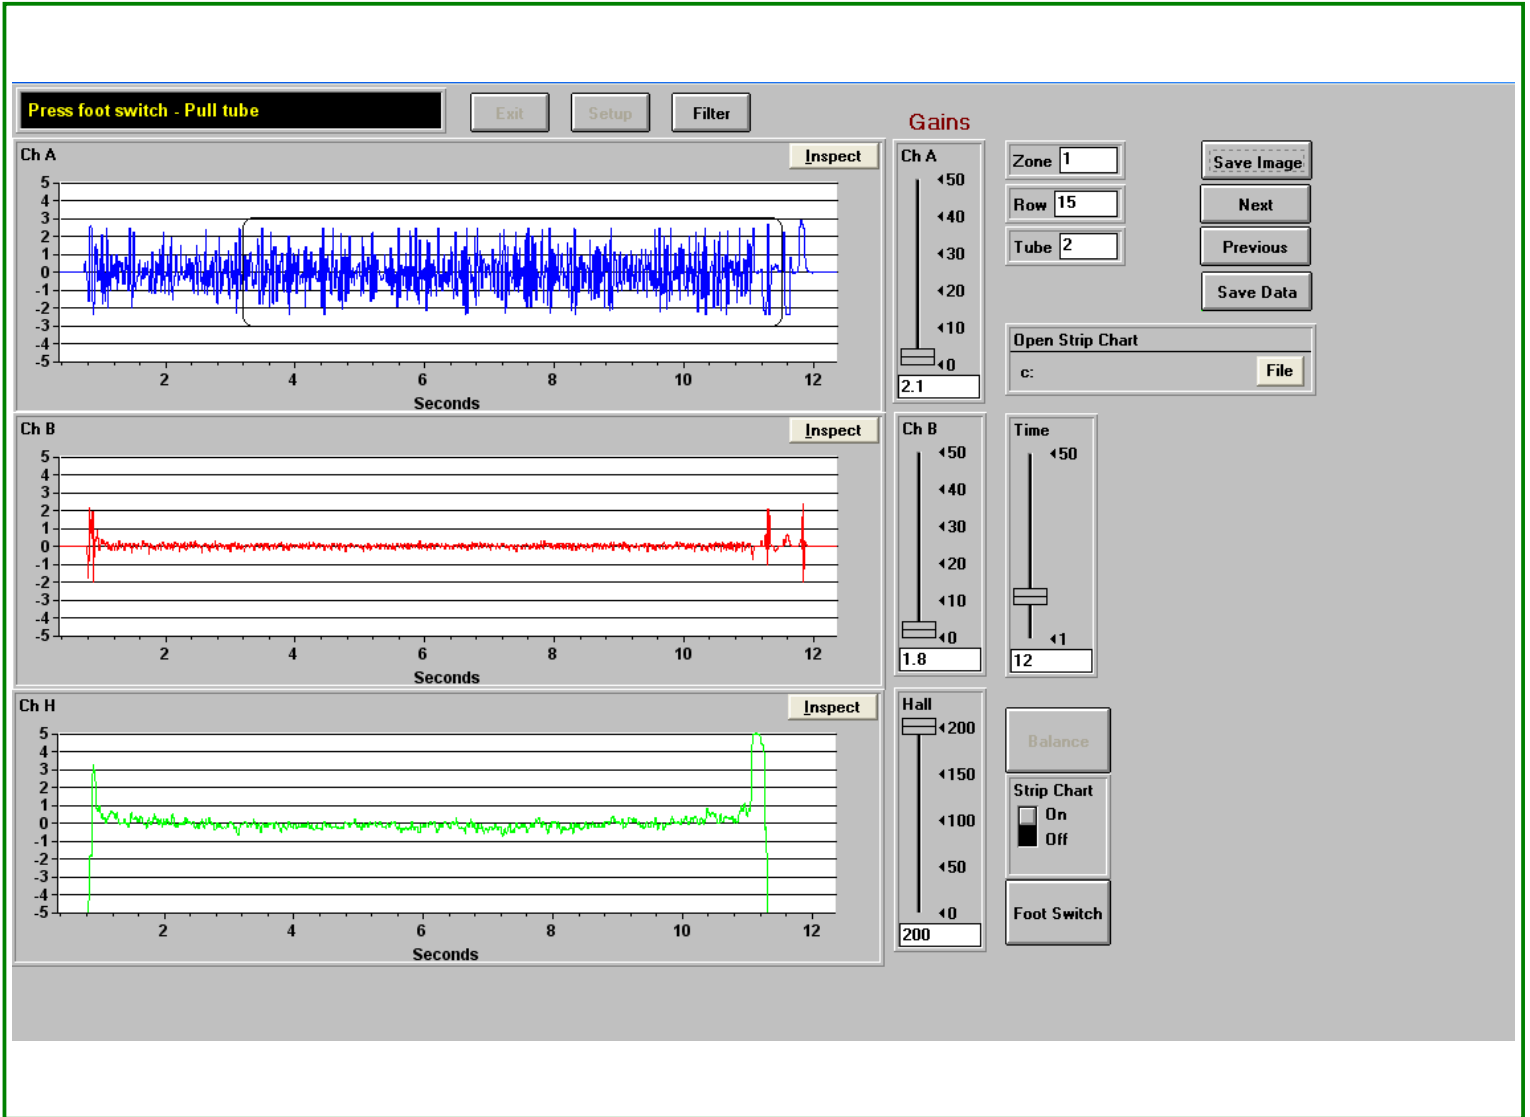
OD PIT 60% - 79% (Row 15 Tube 2)
